# **Intel 82374/5 EB/SB EISA Bridge PCIsset Specification Update**

October 1997

Order Number 297735-003

The Intel 82374EB/SB and 82375EB/SB EISA Bridge may contain design defects or errors known as errata which may cause the product to deviate from published specifications. Current characterized errata are documented in this Specification Update.

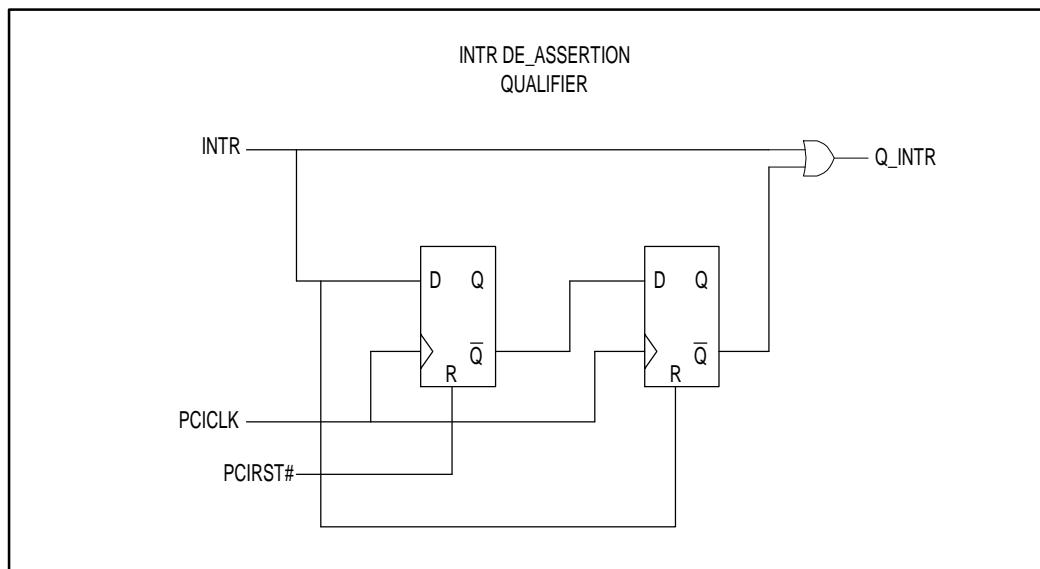
**PROBLEM:** While the ESC is driving INTR to the processor, and PEREQ# is asserted followed by either NMFLUSH# or EISAHLDA going low (for example when ownership of the EISA bus is given to the PCEB, or during interrupt acknowledge cycles), INTR will be de-asserted for one PCI clock.

**IMPLICATION:** Possible de-assertion of INTR for one PCI clock. This may generate spurious interrupts and can be potentially reported as "lost interrupts" under certain operating systems such as Novell.

**WORKAROUND:** A workaround has been provided which will allow de-assertion of INTR only if INTR is low for at least two PCI clocks.

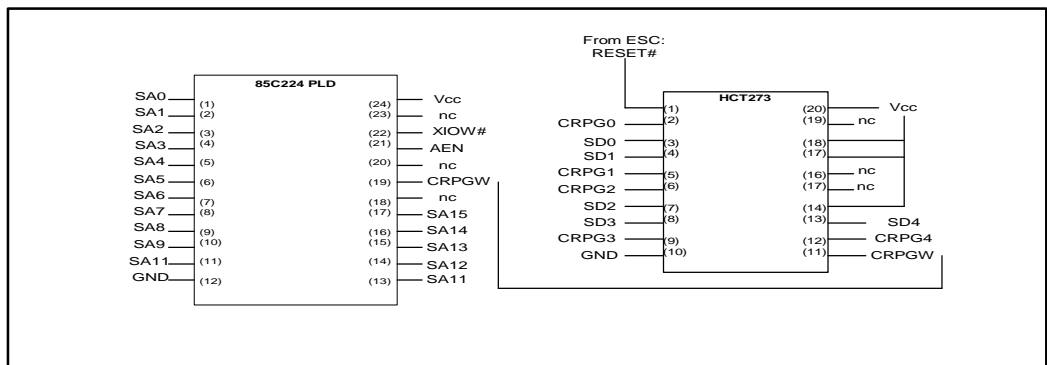
**Figure 2: PLD Workaround #1**

**PROBLEM:** EISA configuration RAM data. The 82374EB may not generate the proper page address on the LA[31:27]# lines during configuration RAM accesses under the following conditions: A DMA cycle or ISA refresh cycle, followed by another pending DMA, followed by an access to EISA configuration RAM (an EISA master should create the same problem).

**IMPLICATION:** During the configuration RAM reads, the 82374EB decodes the cycle properly and generates the signals necessary for the access. The system tries to access page xxxxx and program the proper page address into the C00h register. The 82374EB should drive xxxxx on LA[31:27]# at this time, but instead these address lines may float under the failing scenario. These address lines float when NMFLUSH# (New Master Flush) is asserted. NMFLUSH# gets asserted because of the back to back masters (EISA/ISA/refresh) being serviced.

1. The 85C224 PLD in fig. 2 is programmed to generate an IO write to I/O port 0C00h, which the ESC integrates as a configuration RAM page register. Upon seeing 0C00h on the address bus (SA[15:0]), AEN

asserted high for EISA bus master cycles, and an XIOW# asserted low, the PLD will drive its only output, CRPGW asserted high, as the clock signal input for the HCT273.

The reason for the driving the output high is that the HCT273 needs to see a rising edge on this clock signal in order to latch the correct CRAM page address. The HCT273 is an Octal D-type flip flop which is enabled on the rising edge of its clock signal input. The HCT273 will latch the correct CRAM page address off the data bus (SD[4:0]) and drive the address on its output signals (CRPG[4:0]). CRPG[4:0] are the synthesized versions of LA[31:27] and are tied to the corresponding inputs on the NVRAM. This solution is transparent to the system BIOS.

The actual pin assignments are given in fig. 2 above. This also includes the asserted values of the inputs and outputs (/ = symbol for asserted low). The following is the PLD equation (written in PLDshell Plus) for the data setup of the correct CRAM page address:

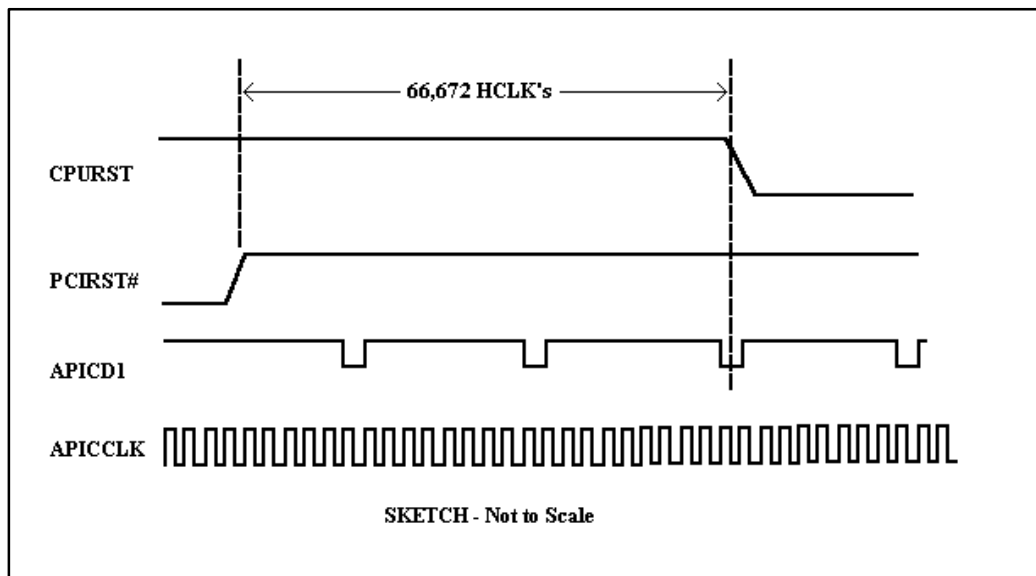
On the A-1 82434NX PCMC, there is approximately a one millisecond delay (specifically 66,672 external host clocks) between the deassertion of PCIRST# and the deassertion of CPURST following a cold system boot (i.e. the PWROK input of the PCMC transitions from low to high). During this one millisecond window, the I/O APIC in the ESC, which is no longer in reset, begins to monitor the APIC bus for valid messages. APICEN (APICD1 = logic 1) and DPEN# (APICD0 = logic 0) remain asserted during this period. The I/O APIC interprets the states of these two bits as the beginning of a normal APIC message and continues to sample the APIC data lines. The I/O APIC responds, per the APIC protocol, by driving APICD1 (APICEN) low once every 20 APICCLK's indicating a checksum error has been detected on the current message. Under these circumstances, this is the correct behavior for the ESC.

From the time that PCIRST# deasserts until the time that CPURST deasserts, the I/O APIC periodically pulses APICD1 low for one out of every 20 APICCLK's. If the pulse on APICD1 (APICEN) aligns with the falling edge of CPU RESET (CPURST), the local APIC's will not be enabled; this prevents proper DP or DP-ready functionality. See the figure below.

**Workaround #1:** Calculate the window for the APICD1 pulse relative to CPURST for a given host clock (HCLK) and APIC Clock (APICCLK) frequency. The following example demonstrates that by using a 60.0 MHz HCLK and a 16.0 MHz APICCLK (0.01% accuracy for both) the APICD1 pulse will be outside the sampling window of CPURST. With these equations, equally acceptable windows can be found for other values of HCLK and APICCLK.

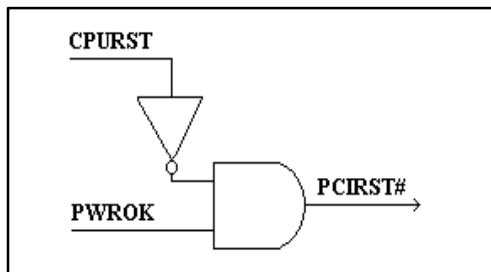
### Workaround "B"

**NOTE:** Due to the combinational logic in workaround "b", there is a short time period (potentially several HCLKs) between the assertion of PWROK and the assertion of CPURST when PCIRST# actually deasserts. This deassertion of PCIRST# does not cause any system problems since it takes at least several hundred nanoseconds before any signals in the ESC will respond.

b) Connect a buffered version of CPURST to an inverter and then connect the output of this inverter to one input of a two-input AND gate. PWROK is the second input to the AND gate. The output of the AND gate becomes PCIRST# for the entire system. Again, the PCMC PCIRST# output pin (pin 147) should be disconnected from the system.

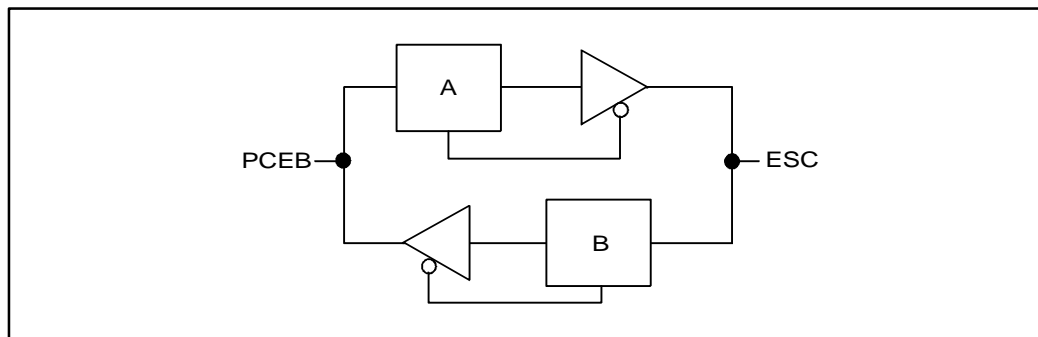
#### AFLUSH# PLD Workaround: Inserted Between PCEB and ESC AFLUSH# Signal

**PROBLEM:** In DP mode and during EISA/ISA/DMA transfers to PCI, an internal AC timing in the PCEB line buffers is violated, resulting in incorrect data driven onto the PCI bus. The failing scenario occurs during an APIC interrupt while the line buffers are flushing data and at the same time filling data. During that time, there is a window where the line buffer pointers do not change correctly.

**WORKAROUND:** There are two possible workarounds to this erratum. The first workaround is to disable the EISA-to-PCI Line Buffers in the PCEB. However, disabling the PCEB line buffers may result in some add-in card incompatibilities.

The second workaround is designed to intercept the AFLUSH# signal between the PCEB and ESC (see figure below) in order to temporarily inhibit the assertion of the AFLUSH# signal to the PCEB. The AFLUSH# signal is held negated if there is an EISA-to-PCI transaction taking place. Once EISAHLDA is negated, the workaround will initiate the AFLUSH# protocol between the ESC and PCEB which will allow the APIC interrupt message to be sent to the processors. The workaround employs two state machines (using the PCI clock) that emulate the AFLUSH# logic from the both the PCEB and ESC perspectives.
